# Identify Cultural Resources Sites Affected by Sea Level Rise at Cape Hatteras National Seashore

Final Report to US National Park Service for Piedmont-South  
Atlantic Cooperative Ecosystems Studies Unit Task Agreement  
No. P13AC01432

Dr. Thomas R. Allen, Principal Investigator  
1-11-2017

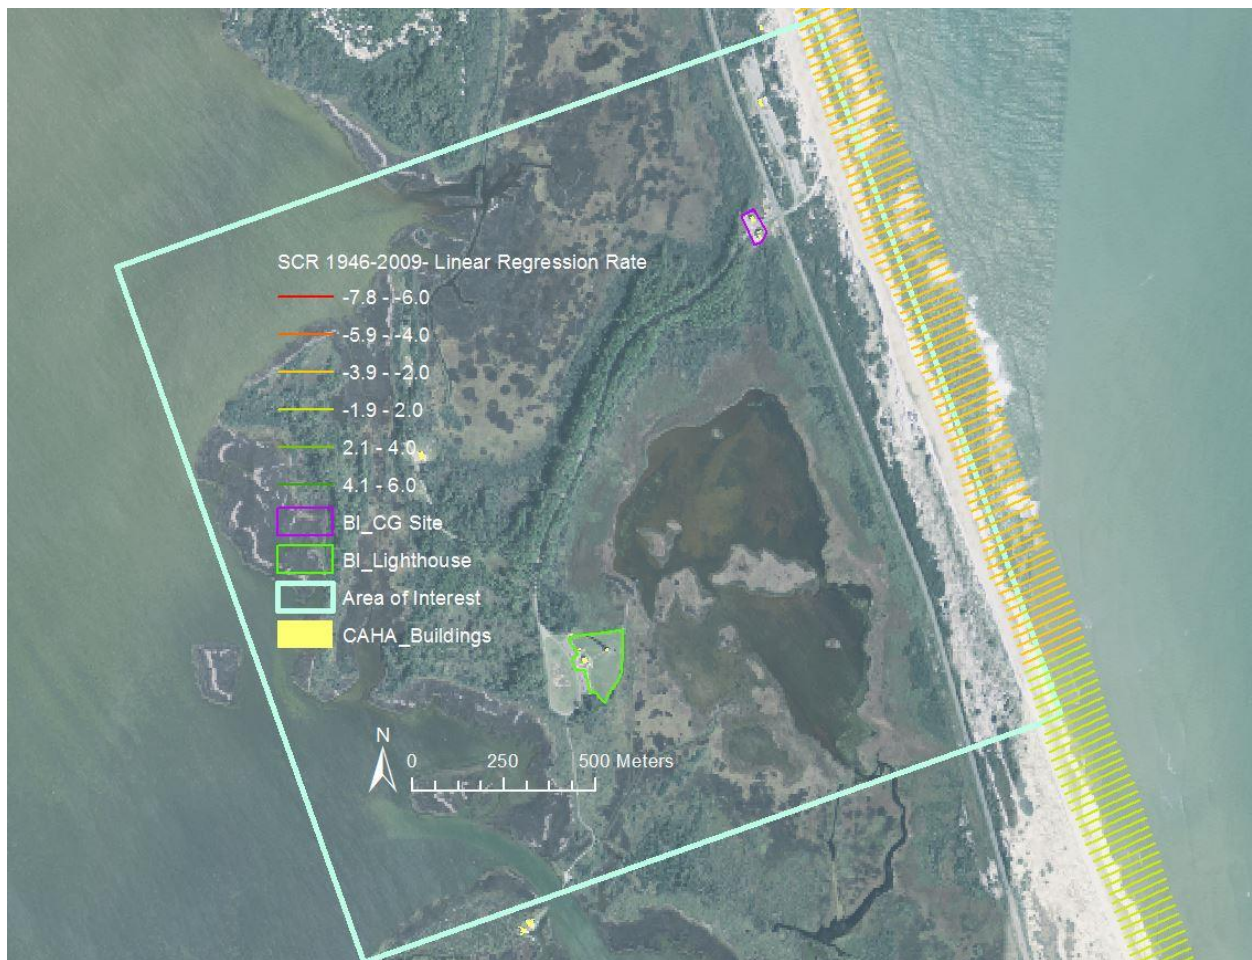
Figure 11. Map of oceanfront shoreline change rates at the Bodie Island area of interest. Linear Regression Rate of Change (LRR) from 1946 to 2009. Distance to Oceanfront Shoreline (DOS) was measured and tabulated using projected LRR rates in Table 3. A net erosional state exists for the oceanfront in this vicinity. Soundside estuarine erosion rates may merit further study for the Bodie Island Lighthouse site.

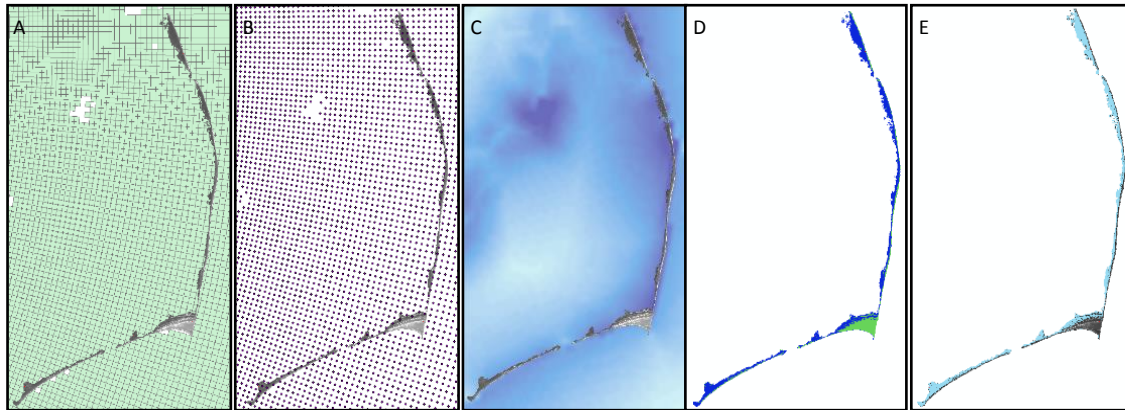
Figure 15. The storm surge inundation mapping process. (A) Project SLOSH MOM polygon (B) Convert SLOSH polygon to points (C) Interpolate water surface (D) Subtract DEM from the inundation surface to develop flood depth grid (E) Create an inundation extent polygon.

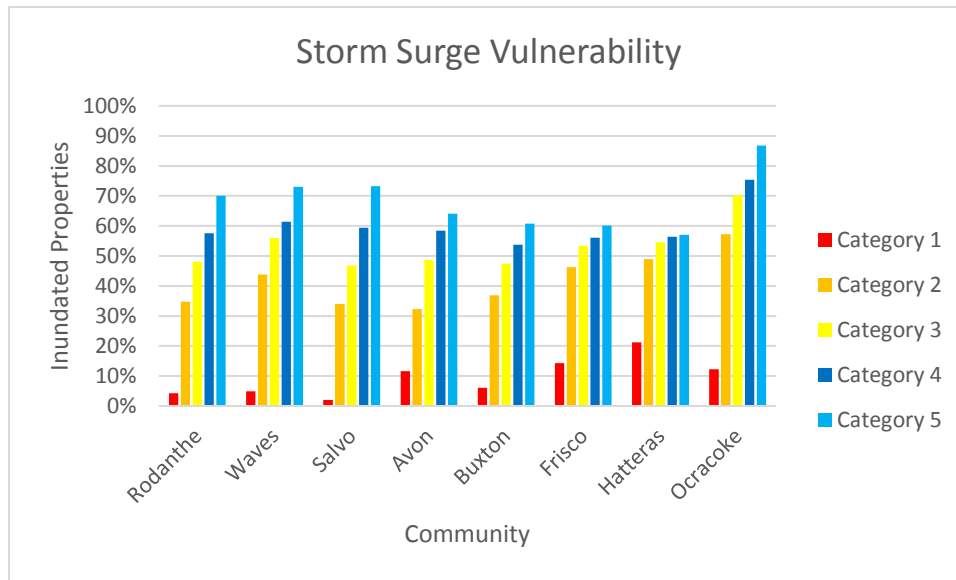
Figure 16. Bar graph of percentage of inundated properties by community. Storm surge vulnerability assessment results are presented as the percent of properties that could be potentially inundated from Category 1 – 5 hurricane events within each community by determining if the inundation exceeded building FFE.

Analysis of each community provides context on how different scale events may impact the functioning of the area (and thus impact park visitation). Interestingly, the development located in Rodanthe, Waves, and Salvo (also known as the “Tri-Villages”) was not very vulnerable to a category 1 hurricane, only 4%, 5%, and 2% of the property within the respective communities had the potential to be inundated. However, the percentage of properties in the Tri-Villages that has the potential to be inundated jumps to over 30% for a category 2 hurricane. In contrast, the results for Ocracoke indicate that 12% of the properties are vulnerable to a category 1 hurricane, however, the percentage is drastically greater (57%) for a category 2 hurricane, the highest for all the communities. Finally, storm surge inundation produced from category 3-5 hurricanes has the potential to be severe for the entire region as the percent of properties vulnerable to inundation is greater than 47% for all of the communities.

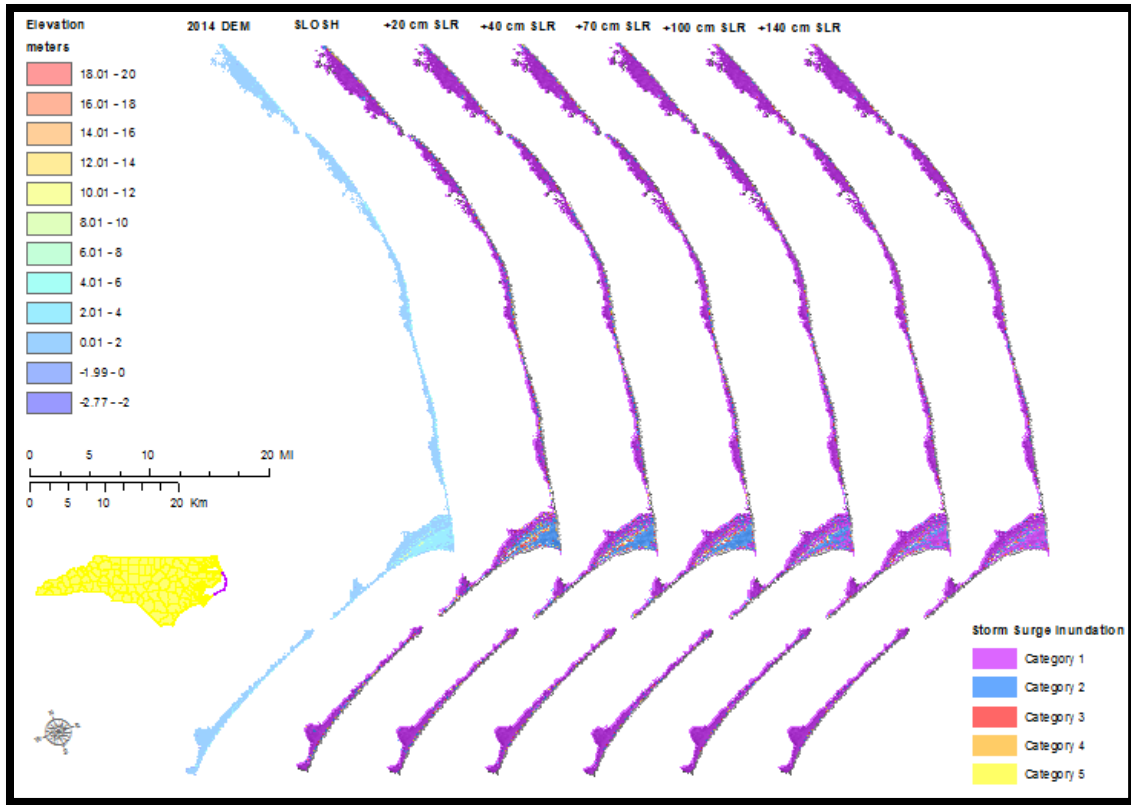
Figure 16. Regional Storm surge inundation extent for downscaled SLOSH MOMs under various relative SLR scenarios.

Figures 15 and 16 illustrate the regional context of CAHA historic districts in relation to storm surges and future sea level rise. Across much of the region today, a category 2 storm surge of a nearby landfalling hurricane is required to inundate most areas of the Outer Banks in our modeling with SLOSH and LiDAR DEMs. In the future, even at +20cm SLR there is evident expansion of areas vulnerable to flooding by category one and two storms. However, this scale of analysis does not allow the assessment of individual buildings. These figures, it should be noted, are cartographically coarse-scale, yet the modeling was conducted at finer resolution. Section 4 covers the results and discussion for CAHA historic districts and structures.

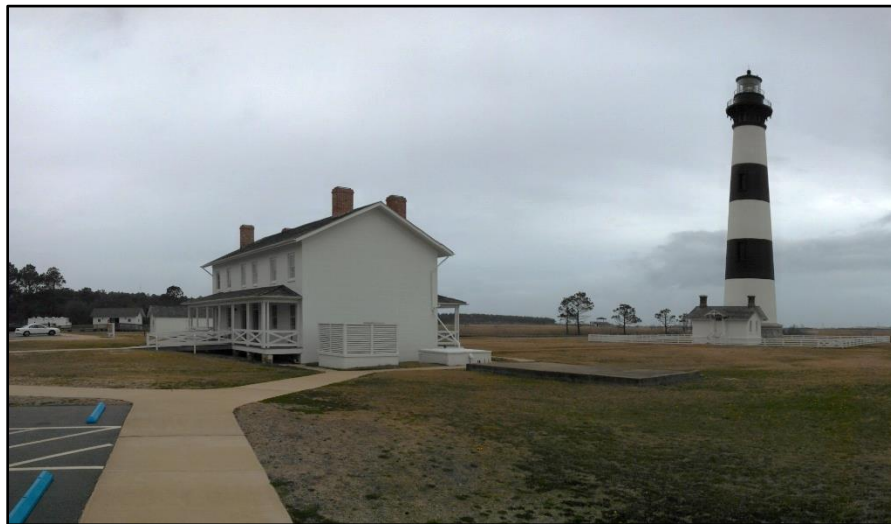
Waves from the estuarine side of the Bodie Island Historic District were reported to have swashed through the parking lot almost to the Light Keepers' Station (Figure F2) during Hurricane Irene in 2011. From the ground this region seemed appears sheltered, yet the 2012 NAIP DOQQ revealed the proximity to Roanoke Sound, Oregon Inlet, and the Atlantic Ocean (Figure F3).

**Figure F2.** Bodie Island Light Keepers' Station and, Oil House, and Lighthouse (Photograph taken March 29, 2012).

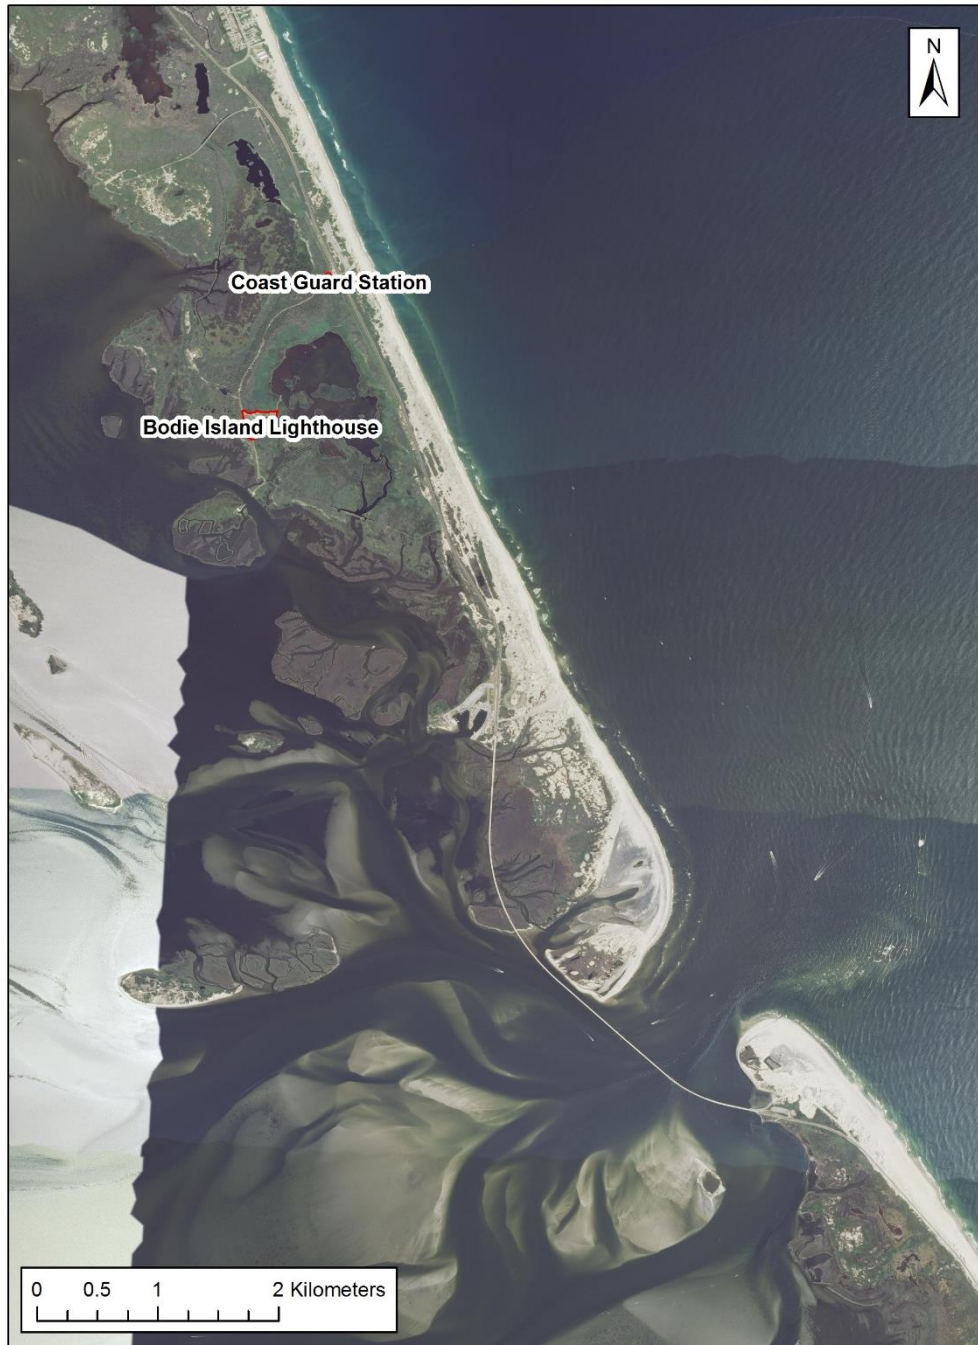
**Figure F3.** Aerial Imagery of Bodie Island Coast Guard Station and Lighthouse (NAIP DOQQ, 2012).

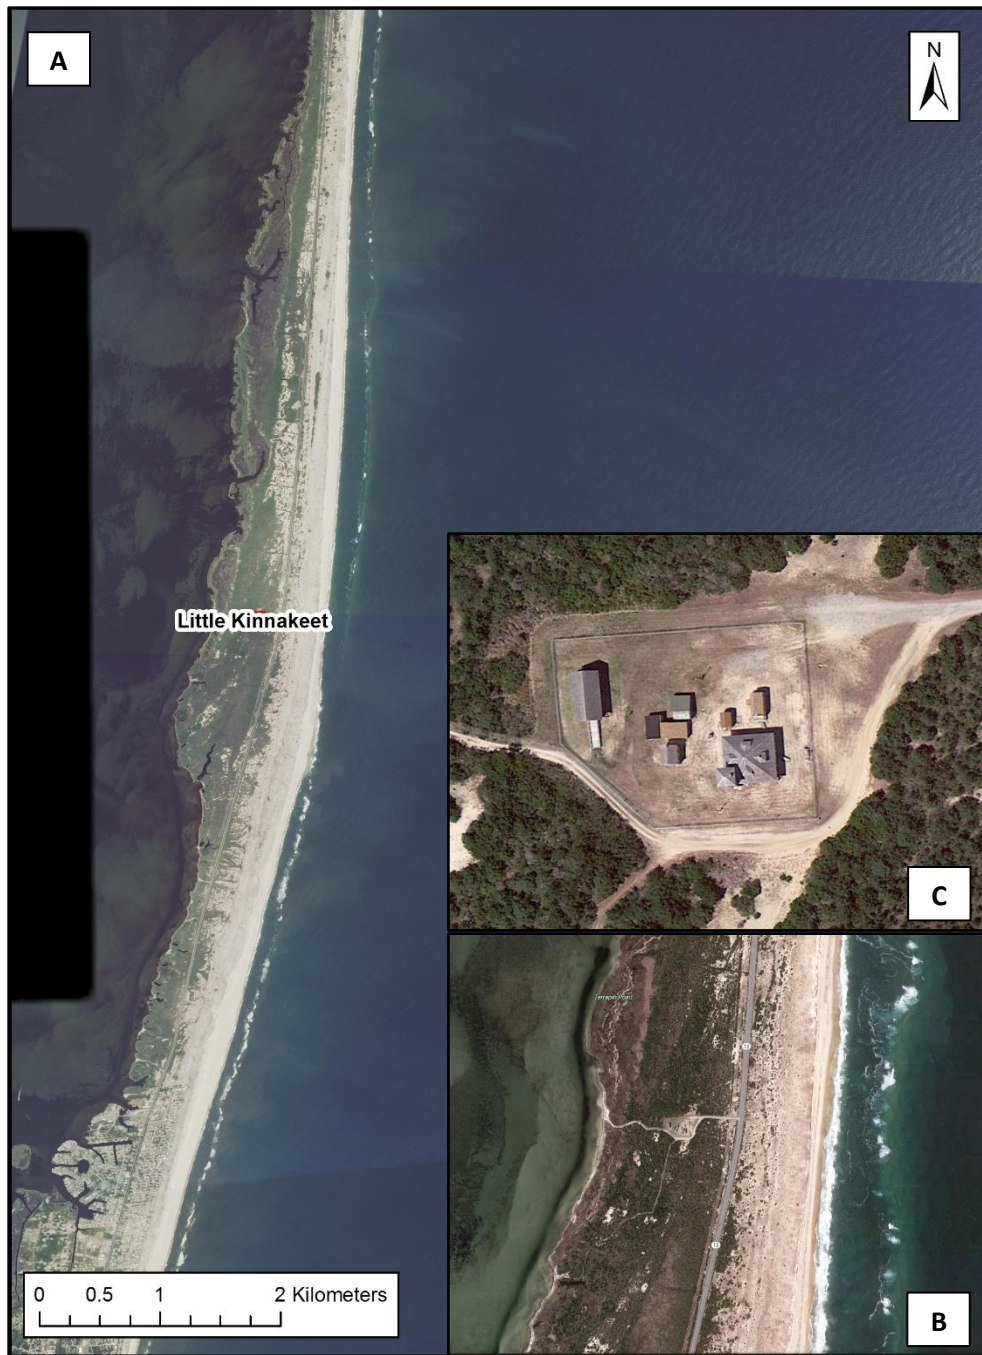
Little Kinnakeet Historic District was fenced off from the public and undergoing restorations. This historic district is located on the estuarine side along an undeveloped stretch between Salvo and Avon (Figure F4).

**Figure F4.** A) Aerial Imagery of Little Kinnakeet (NAIP DOQQ, 2012), B) Aerial imagery of Little Kinnakeet (Google Maps, 2014), C) Aerial imagery of Little Kinnakeet Historic District (Google Maps, 2014).

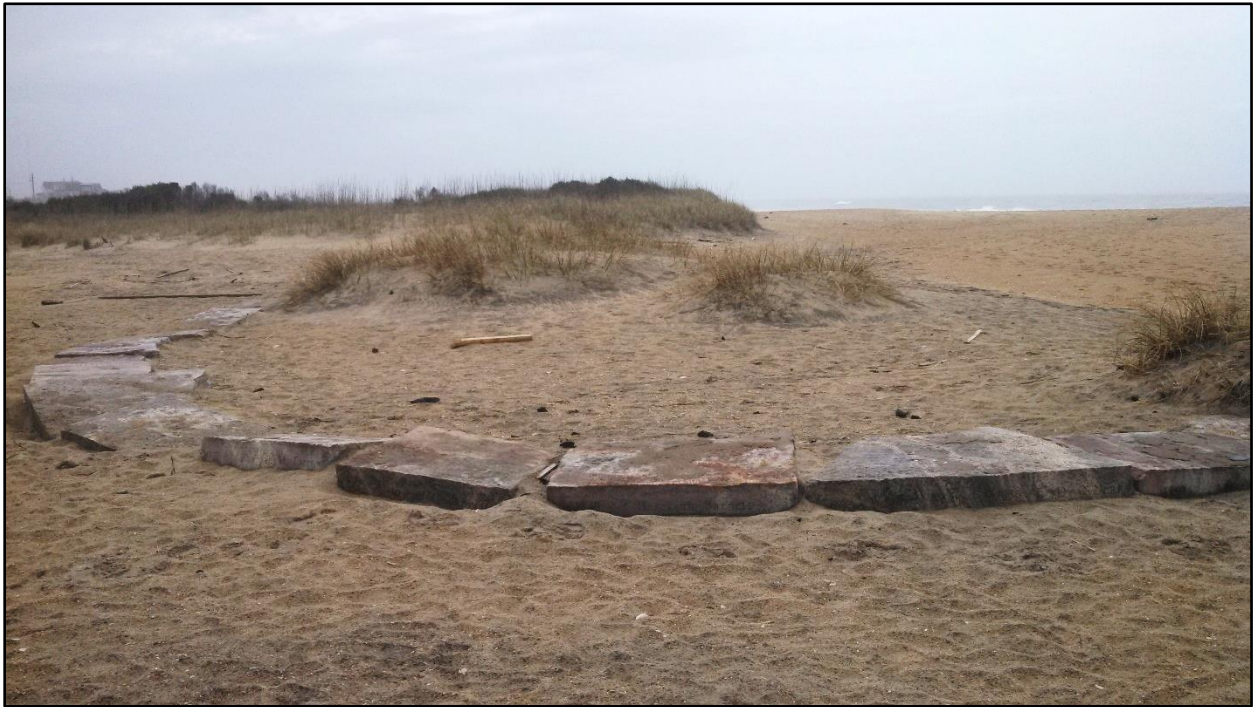
**Figure F5.** Former location of the Cape Hatteras Lighthouse, which is now occupied by Foundation Stones that were placed there after the lighthouse was relocated in 1999 (Photograph taken March 29, 2014).

Cape Hatteras Lighthouse once stood at the site now marked by a ring of foundation stones (Figure F5). These granite foundation stones had the names of the keepers that once served the lighthouse

engraved on them. Many of the original stones had been buried or relocated from the physical forces from Hurricane Sandy, and now formed a semi-circle known as the “Keepers of the Light Amphitheater.”

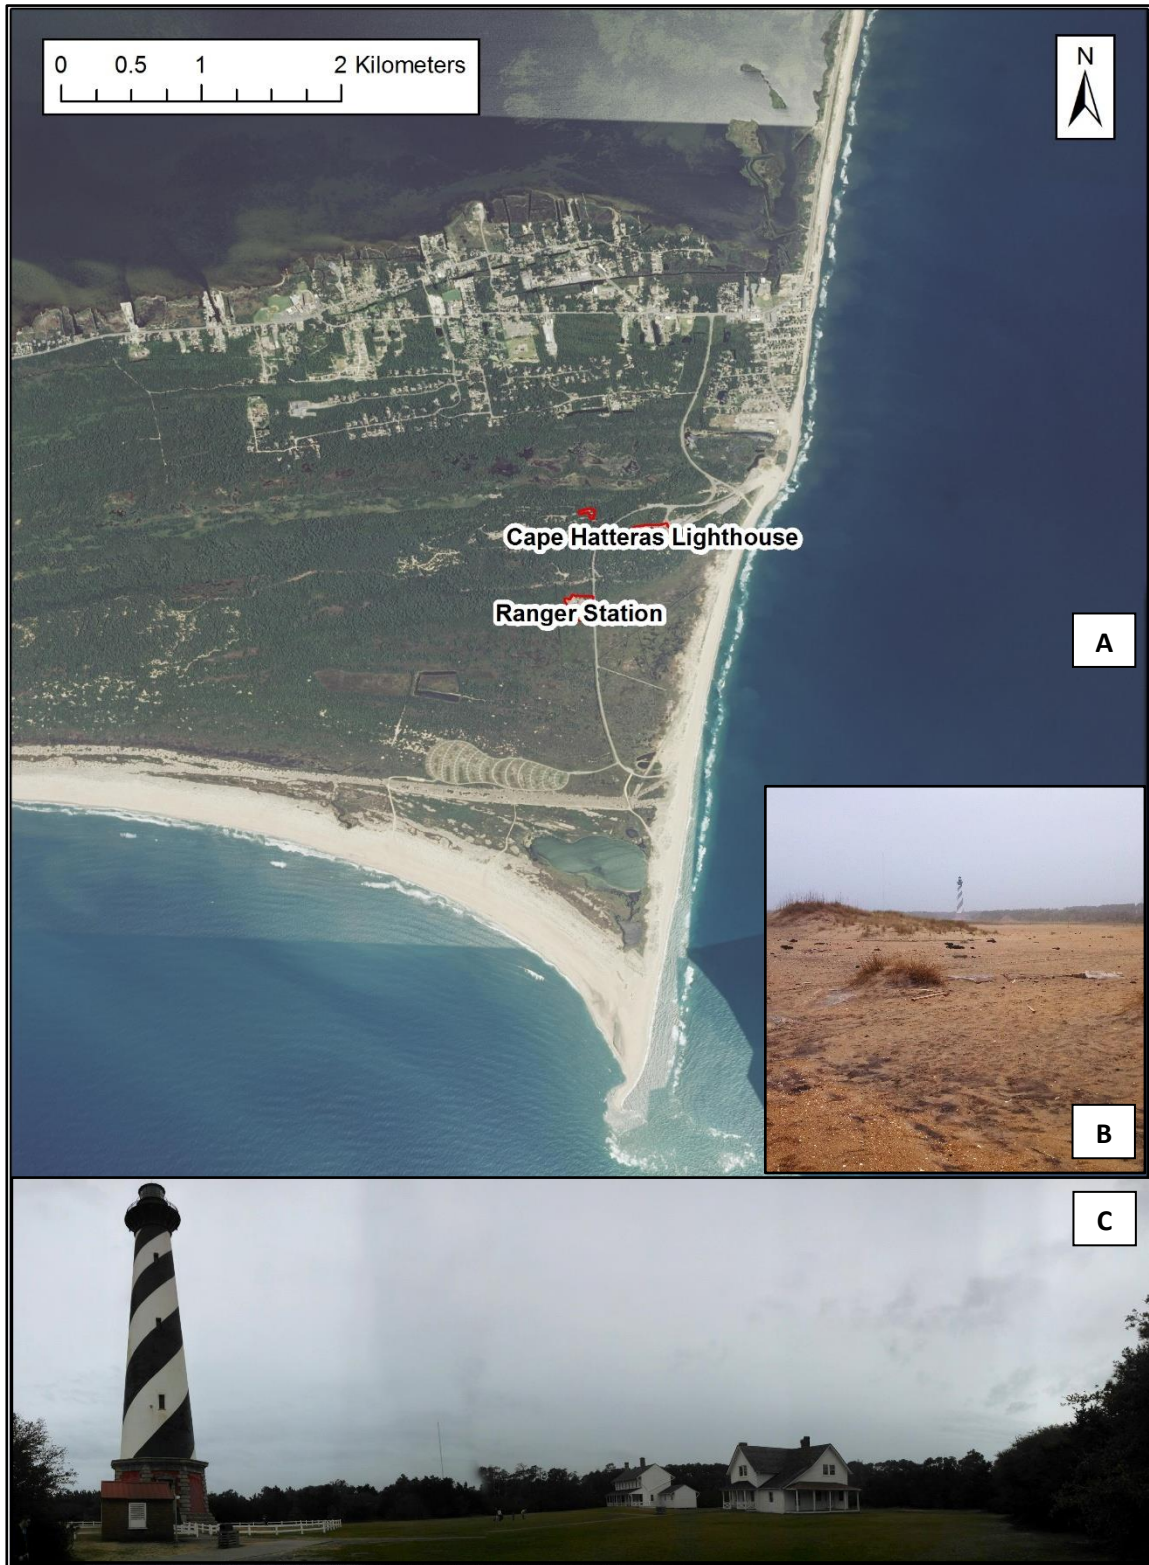
**Figure F6.** A) Aerial Imagery of Cape Hatteras Lighthouse, Ranger Station, and CCC Cabins (NAIP DOQQ, 2012), B) Looking from the foundation stones towards Cape Hatteras Light House (Photograph taken March 29, 2014), C) Relocated Cape Hatteras Lighthouse District (Photograph taken March 29, 2014).
